STERLING Woods II – The Willows Village
Minutes of the Annual Meeting
November 15, 2016

Issue: Quantify if there is sufficient lighting on Cypress Drive.

November 20, 2016 Steve Griffing, Vicki Vaughan 1504 Cypress Drive

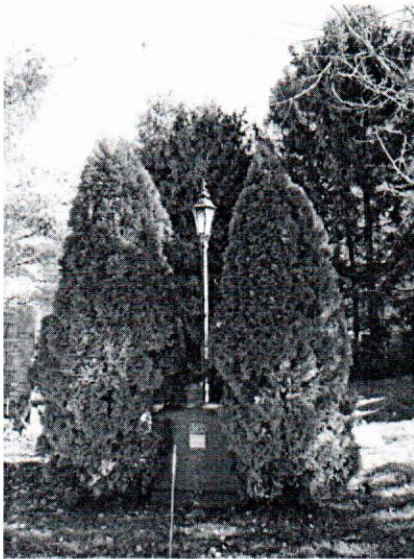
Discussion: Where Heartwood, Bradford, Revere and Hancock have an average of 1 lightpost for every 6 units, Pinnacle and Cypress have approximately 1 lightpost for every 12 units. Cypress has fewer than Pinnacle and the effectiveness of street illumination is further hindered by placement and dense evergreen arborvitae landscape blocking some by almost 100%. Layout of Pinnacle in a loop tends to help with illumination as lightposts can illuminate more than one area (i.e. lightpost opposite 1702 covers loop, parking lot and extension although this could be improved with trimming of arborvitae). Cypress is one long road with only 5 lightposts. Two of the lightposts are next to each other at the end loop which results in only 3 for the entire balance of the long road. There is a significant unlit area from Silversmith to the first lightpost (1306) which is almost 100% obscured by arborvitae landscaping. One of the lightposts at the end circle is about 50% obscured by arborvitae.

1306 Cypress Almost Total Blockage

Suggestion: Immediate improvement can be realized by severely trimming or removing the arborvitae in several locations. Consideration should be given for additional lightposts on Cypress or at minimum making provisions for additional lights when repaving, so that no paving needs to be disturbed should the decision be made later to add lightposts. We would suggest adding lampposts at the following locations:

Summary: The recommended solution is to remove the obstructing completely and save 10% by doing these on winter rates and replace them with lower growing bushes in the spring. Consideration was given to pruning only, but it was felt that this would not alleviate the problem and there would be ongoing future costs for trimming.

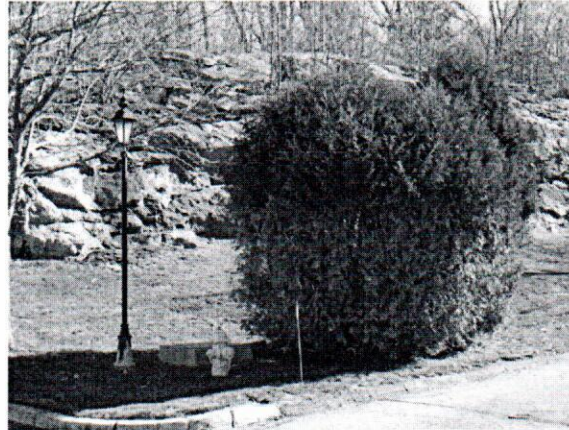
End Circle Cypress

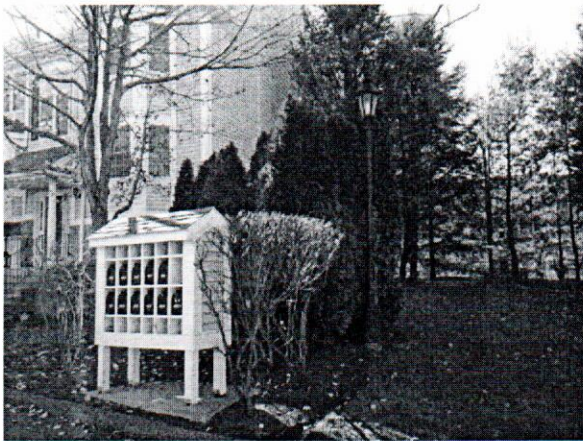
- Logging Trail circle at 119
- Revere at end Circle blocking half of circle
- Hancock opposite 2002
- Pinnacle at 1702 blocking visitor parking and portion of upper Pinnacle
- Pinnacle at 1306 block about half of its illumination

Pinnacle 1306 Partial Blocking

Additional Trimming. In addition to the two lightposts indicated above on Cypress, we identified several other lightposts in the complex that should be considered for trimming to improve lighting. Note: We only considered the blockage by evergreen bushes such as arborvitae and not by deciduous trees.

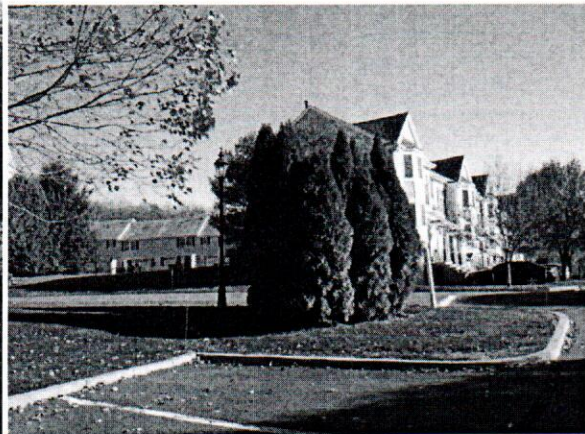
Pinnacle 1702 Blocking road and parking

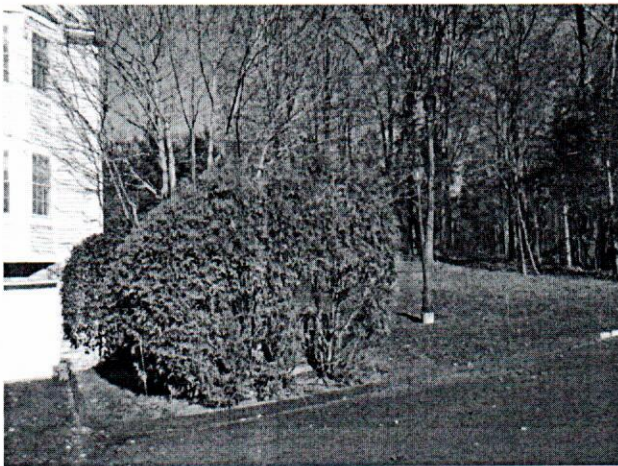
Revere, End Circle Partial Blocking

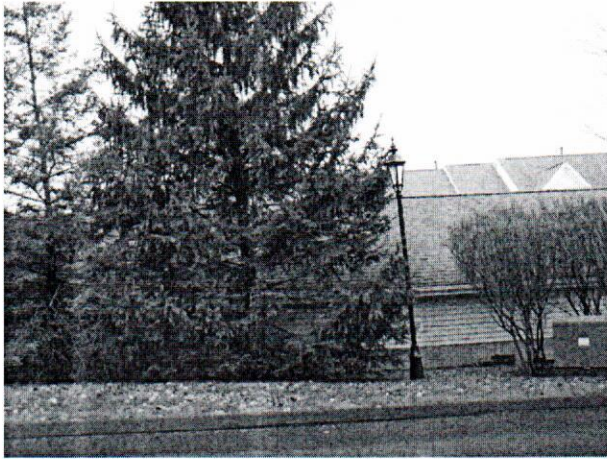
Hancock 2002 Partial Blocking

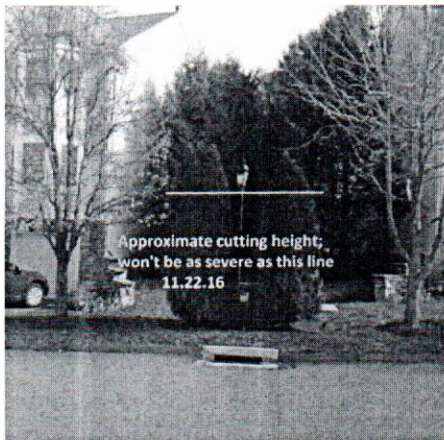
Consideration was given to doing minimal trimming to preserve the arborvitae as suggested by Bartlett Tree Service (Picture 1) but this would not dramatically improve the illumination on the street. In order to maximize the illumination, more severe pruning is needed (Picture 2 Red Line). But this would look unsightly and would most likely kill the plant. Therefore it was concluded that pruning would be a waste of money.

Pruning of tree per Picture 1 was \$159.52

The solution is to remove the bushes and replace them in the spring.

The cost to totally remove the bushes and grind down the stump as close to the grade as possible is \$409.45.

Replacing in the spring would be included in the annual shrub replacement list next spring and is estimated at \$50 each x 4 = \$200.

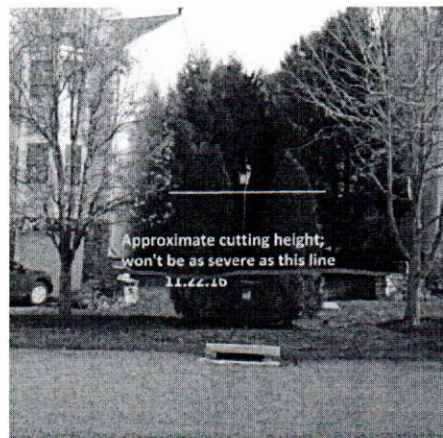
No estimate given for pruning per Picture 2 as that would kill the plant.

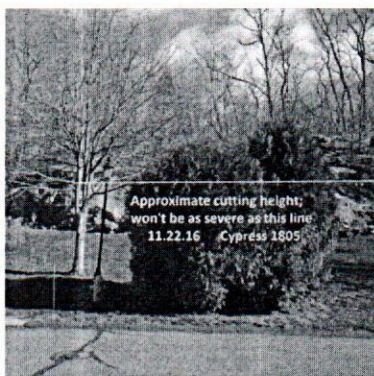
1805 Cypress

Again, the proposed pruning cost at the estimated line would be \$303.10 (more expensive than 1306 due to size of bushes) and total removal is \$409.45. Replacing in the spring would also be approx \$200.

Pruning at the indicated level would also not improve the illumination up Cypress away from the Circle where it is needed so the recommendation is also for removal and replacement with shorter bushes in the spring.
